**DEPARTMENT OF TRANSPORTATION**

Contract #: 04-0120F4Cty: SF/ALA Rte: 80 PM: 13.2/13.9File #: 1.28**WELDING INSPECTION REPORT****Resident Engineer:** Pursell, Gary**Address:** 333 Burma Road**City:** Oakland, CA 94607**Report No:** WIR-012802**Date Inspected:** 18-Mar-2010**Project Name:** SAS Superstructure**OSM Arrival Time:** 630**Prime Contractor:** American Bridge/Fluor Enterprises, a JV**OSM Departure Time:** 1500**Contractor:** American Bridge/Fluor Enterprises, a JV**Location:** Job Site**CWI Name:** See Below**CWI Present:** Yes No**Inspected CWI report:** Yes No N/A**Rod Oven in Use:** Yes No N/A**Electrode to specification:** Yes No N/A**Weld Procedures Followed:** Yes No N/A**Qualified Welders:** Yes No N/A**Verified Joint Fit-up:** Yes No N/A**Approved Drawings:** Yes No N/A**Approved WPS:** Yes No N/A**Delayed / Cancelled:** Yes No N/A**Bridge No:** 34-0006**Component:** Orthotropic Box Girders (OBG)**Summary of Items Observed:**

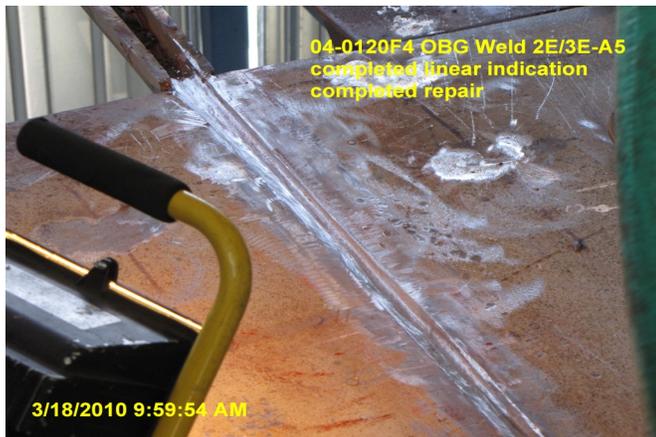
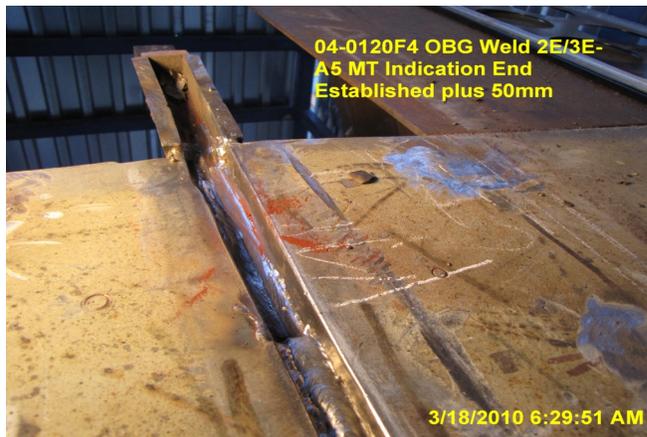
The QA inspector periodically observed ABF welding personnel Chun Fai Tsui and Huang Jin Quan performing grinding and cleaning of the backgouge and backing bar removal of the second side of the weld. QC inspector Mike Johnson was noted to be present with QC inspector Tom Pascaulone relieving Mr. Johnson in order to perform Magnetic Particle Testing (MT) for the completed backgouge prior to initiating welding of the second side. The QC inspector performed the MT with minor indications noted for removal by further grinding and the testing was performed again with no rejectable indications noted by QC. The QA inspector performed an informational only MT of roughly 10% of the weld joint with no rejectable indications noted at the time of review. QC inspector Mike Johnson returned and verified the welding parameters for the Flux Cored Arc Welding (FCAW) process to be in accordance with the WPS noted as ABF-WPS-D15-3040B-3 prior to initializing the welding of the joint. Mr. Johnson was observed verifying the pre heat and welding parameters in accordance with the WPS during the initial passes of the joint. The QA inspector relayed to the QC inspector it appeared the

welders were not cascading the ends of the weld passes and instead were ending each pass at the same location. This information was relayed to welding foreman Dan Iraci in which Mr. Iraci removed several small passes and demonstrated the technique to the welding personnel. It was noted several areas revealed small slag pockets at the initiation point of the weld and this information was relayed to the welders by Mr. Iraci also. This area was covered by other QA personnel for the balance of this date.
